**MRI Head Coil Malfunction Producing
Artifacts Mimicking Malformation of
Cortical Development in Pediatric Epilepsy
Work-Up**

N. Kashani, N. Khan, J.M. Ospel and X.-C. Wei

AJNR Am J Neuroradiol published online 2 July 2020
<http://www.ajnr.org/content/early/2020/07/02/ajnr.A6639>

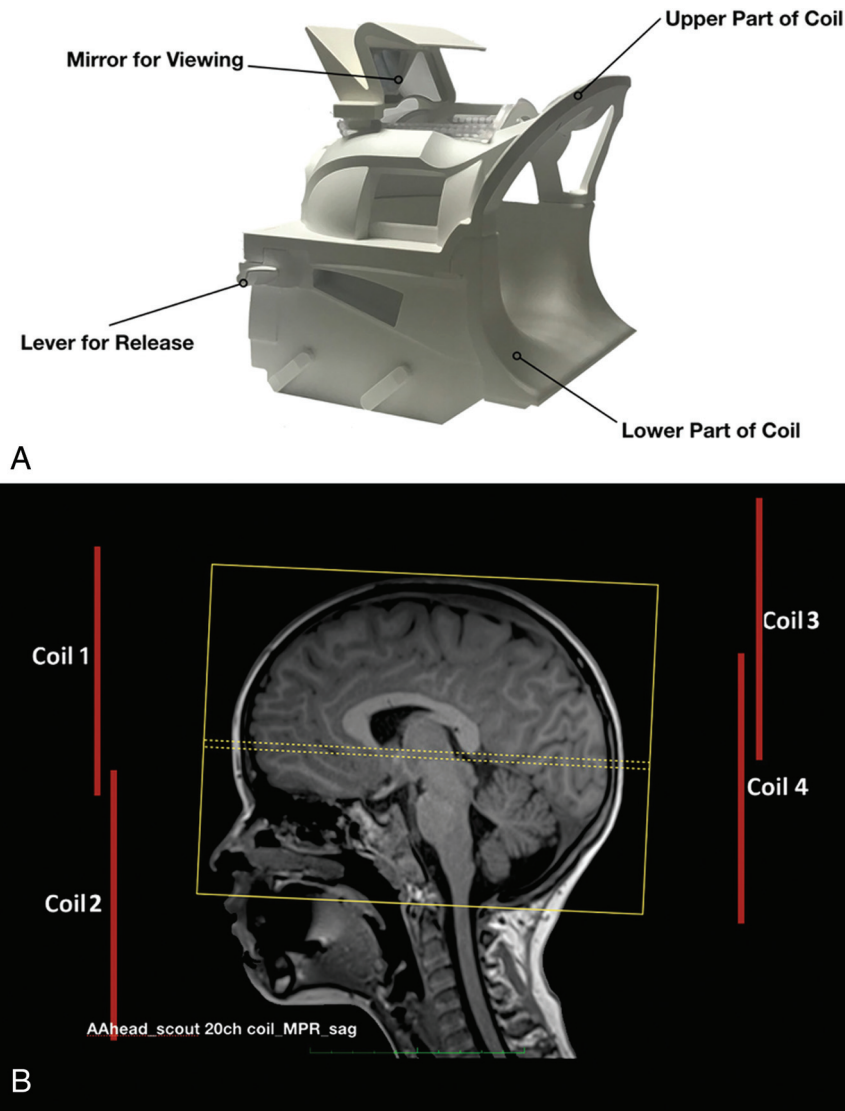
Recently, we encountered a series of incidents in which the 2 anterior groups of coil elements were inadvertently disconnected from the MR imaging system during patient scanning. This malfunction could not be eliminated by the scanner operator, neither could it be identified in the DICOM header. The resulting artifact occurred exclusively anteriorly and bilaterally and can be mistaken for a cortical abnormality. In the first incident, the scan was interpreted by neuroradiologists as possible polymicrogyria until a repeat scan 3 weeks later showed a normal cerebral cortex, whereas in the following incidents, the neuroradiologists recognized the artifact, thereby avoiding misdiagnosis.

FIG 1. Picture of a typical multichannel MR head coil (A) shows the positions of the multiple coil elements. A modified screenshot from the operator console of the system (B) shows indicators of the positions of the 4 groups of a 20-channel head coil. Red bars show the position of the individual groups of head coil elements. The coils 1 and 2 are anterior coils, while the coils 3 and 4 are posterior coils.
