Compatibility of cervical spine braces with MR imaging: a study of nine nonferrous devices.

D A Clayman, M E Murakami and F S Vines

AJNR Am J Neuroradiol 1990, 11 (2) 385-390 http://www.ajnr.org/content/11/2/385

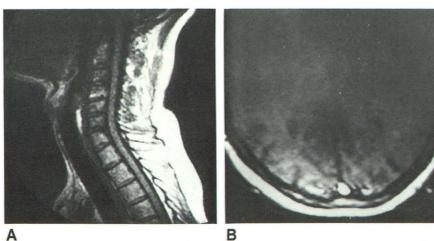
Fig. 3.—T1-weighted cervical spine MR image obtained with the patient wearing a modified Guilford cervical orthosis. Minimal distortion of the posterior cervical soft tissues below the occiput is presumably due to an electrical loop formed by the mandibular and occipital shells.

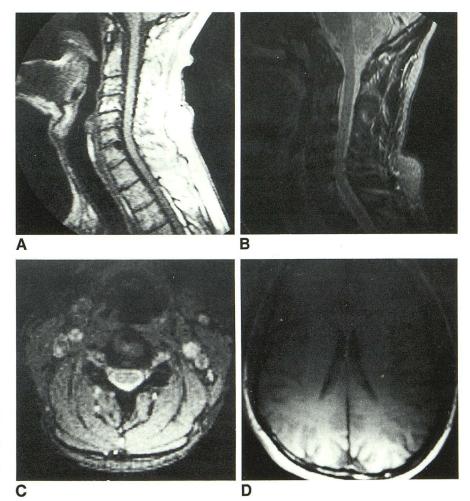
Fig. 7.—A-D, Cervical spine (A-C) and brain (D) MR images obtained with a modified PMT halo orthosis containing graphite-carbon composite components. Satisfactory sagittal T1 and T2 and axial gradient-echo images were produced. Brain images obtained with a surface coil suffer from signal fall-off.

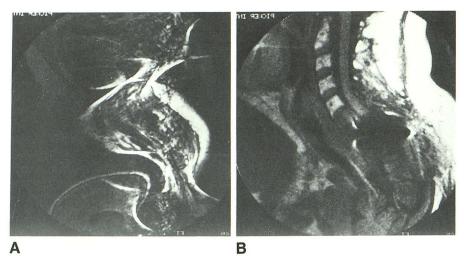
A patient fitted with a standard Guilford cervical orthosis was inadvertently scanned at a later date, and the images produced were significantly distorted by blowout artifacts (Fig. 8A). Repeat scanning with the device removed confirmed the orthosis as the cause of the artifacts (Fig. 8B).

Fig. 8.—*A*, Cervical spine image with a standard Guilford cervical orthosis. Ferrous-containing rivets and fasteners cause severe blowout artifacts.

B, Same patient as in *A* with the orthosis removed. Fixation wires induce blowout artifact in the area of interest.
