AJNR Am J Neuroradiol 2013, 34 (5) E47-E50

Invisible Metallic Microfiber in Clothing Presents Unrecognized MRI Risk for Cutaneous Burn

ABSTRACT

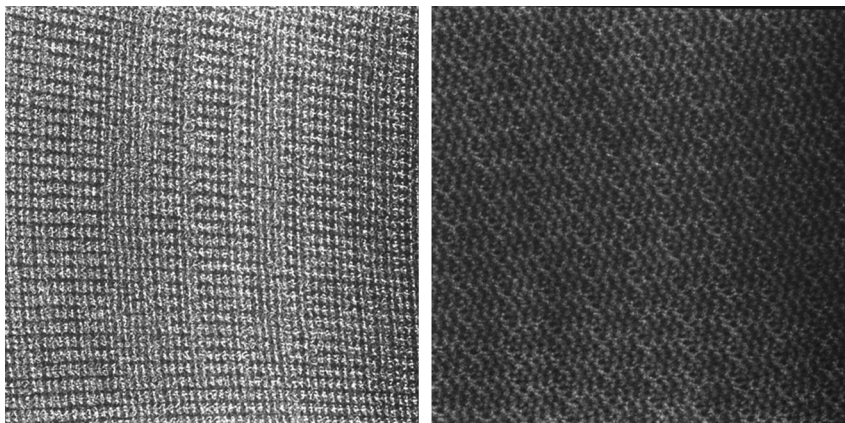
We suspect that our patient sustained cutaneous burns secondary to conductive SMF embedded in her undershirt. We retrospectively imaged the undershirt by high-resolution digital radiography (Fig 3) and demonstrated an interleaving weblike pattern of radiopaque SMF. We further demonstrated the enhanced electrical conductivity of the SMF fabric relative to control polyester and cotton fabrics by measuring the resistance by using a volt/ohm multimeter. The undershirt demonstrated low resistance (on the order of 10 ohms), which increased monotonically as a function of the distance separating the probes. In contrast, the resistance for both the cotton and polyester fabrics was infinite.

FIG 3. A digital radiograph demonstrating the metallic content of the fibers of the undershirt. Left image shows the radiopaque silver microwave fabric from the Boston Silver T. Comparison right image shows cotton fabric from a thermal undershirt.
