Black Holes on MR Images of the Brain of Patients with Björk-Shiley Heart Valves: Additional Observation in Three Cases

AJNR Am J Neuroradiol 2003, 24 (3) 512-514
<http://www.ajnr.org/content/24/3/512>

Case Report

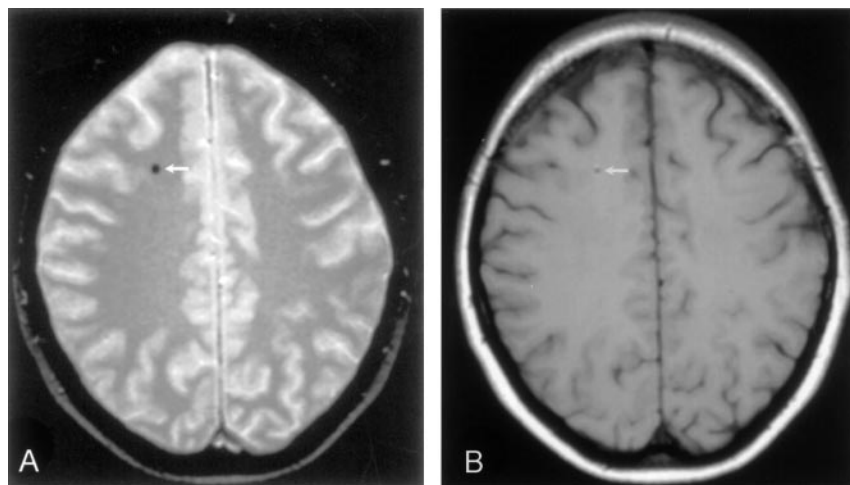
FIG 1. Patient 2.

A, Axial view T2*-weighted gradient-echo image (710/27.6/2 [TR/TE/number of excitations]) shows a black hole (arrow). Repeat images obtained after 1 year appeared unchanged, with no increase in number or size of black holes (not shown).

B, Corresponding axial view T2-weighted spin-echo image (1380/60/2) shows the same black hole with a typical white halo (arrow).

The substances that could be responsible for these susceptibility artifacts can be divided approximately into four different groups: air, calcium, microhemorrhages, and foreign metallic particles. Air can be ruled out because of expected resolution over time, which we did not observe on the second set of images obtained for patient 2 after 1 year. As for calcium deposits, these have slightly distinct appearances on MR images and lack the white halo, which was clearly visible on the T2-weighted spin-echo sequence of pa-

tient 2 (Fig 1B). In addition, the blooming of signal intensity loss on the T2*-weighted gradient-echo sequence is not observed with calcium deposits.

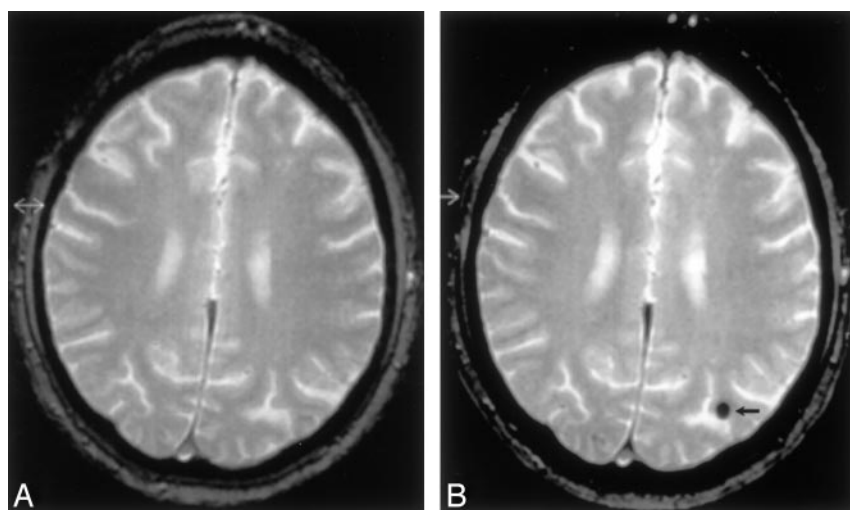
FIG 2. Patient 3.

A, Axial view T2*-weighted gradient-echo image (710/27.6/2), obtained 1 week before double valve replacement, shows no apparent abnormalities.

B, Axial view T2*-weighted gradient-echo image (710/27.6/2), obtained 5 months after successful double valve replacement, shows one of the two large black holes (arrow).

Interestingly enough, the images of patient 3 showed artifacts after the Björk-Shiley convexo-concave valve explantation and not before. When valve wear or damage is considered for this patient, one would expect that the "exposure time" of the valve to the circulation was sufficient to cause some artifacts. In addition, no cracks or fractures were discovered with scanning electron microscopy research after valve removal, although common valve wear was obvious. Based on the postoperative changes seen on the MR images, it seems that surgery played a more important role in the formation of these artifacts. This could also be the case for the first two patients for whom we did not have MR images of the brain before explantation. If intensive cardiac surgery were to induce these artifacts, however (ie, by means of surgical instrumentation or cardiopulmonary bypass machines), one would expect to observe it more frequently in daily practice. This may be explained in part by considering that patients with prosthetic heart valves often are unjustly withheld from MR imaging investigation because of fear of valve failure being induced by the magnetic field (14). Moody et al (15) have reported extensively on microembolic phenomena associated with cardiopulmonary bypass, combining clinical presentations and histochemical staining. Unfortunately, in our cases, no pathologic or histochemical evidence is available. In general, detrimental effects on the brain after cardiopulmonary bypass
