AJNR Am J Neuroradiol 1998, 19 (2) 317-319 http://www.ajnr.org/content/19/2/317

Dental Bur Fragments Causing Metal Artifacts on MR Images

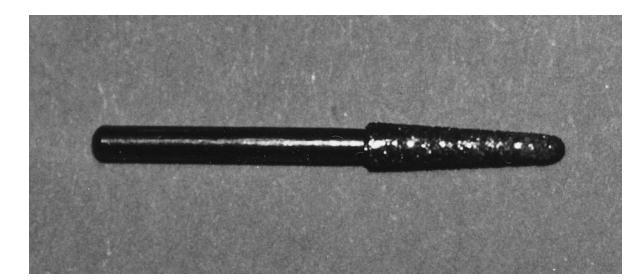
Fig 1. Round-end tapered diamond bur.

Two dogs, with a mean weight of 10 kg, underwent dental prosthetic treatment. The dogs were anesthetized with 0.1 mL of pentobarbital intravenously, and ventilated with a mixture of oxygen and halothane. Both lower second premolars were prepared for full-cast crowns using a round-end tapered diamond bur (Fig 1). The crown margin was placed subgingivally on the right side (1 mm below the free gingival margin) and at the same level as the free gingival margin on the left side. After preparation, an impression for full-cast crowns was taken with silicone-based material. Seven days later, full-cast crowns (12% gold, 56% silver, 20% protactinium, 10% copper, 1.5% zinc, and 0.5% indium in composition) were cemented with glass ionomer cement (Ketac silver glass cement, ESPE, Pharmazeutischer Praparate GmbH & Čo, Seefeld, Germany) on both second premolars. Seven days later, the animals were examined by MR imaging. MR studies of the mandible were performed twice. After completing this MR examination, we removed the full-cast crown in the right lower second premolar and cemented on an anterior tooth with glass ionomer cement. No procedure was done to the crown on the left side. MR examinations were again performed using the same pulse sequence (see below). The animals were killed as part of a separate investigation unrelated to the head and neck region. Both lower second premolar regions were examined histopathologically and by X-ray fluorescent element analysis (element analyzer; JEOL Ltd, Tokyo, Japan).

There are many kinds of dental burs in dentistry (13). In our study, we used a diamond bur consisting of a steel core covered with diamond chips. The diamond burs are used at higher speeds of rotation, particularly for extracoronal reduction of tooth tissue. Presumably, small bits of metal from the bur core are chipped when in contact with the tooth. These bits of metal are deposited in the traumatized gingiva. Dentists cannot perform a prosthetic procedure without a diamond bur.

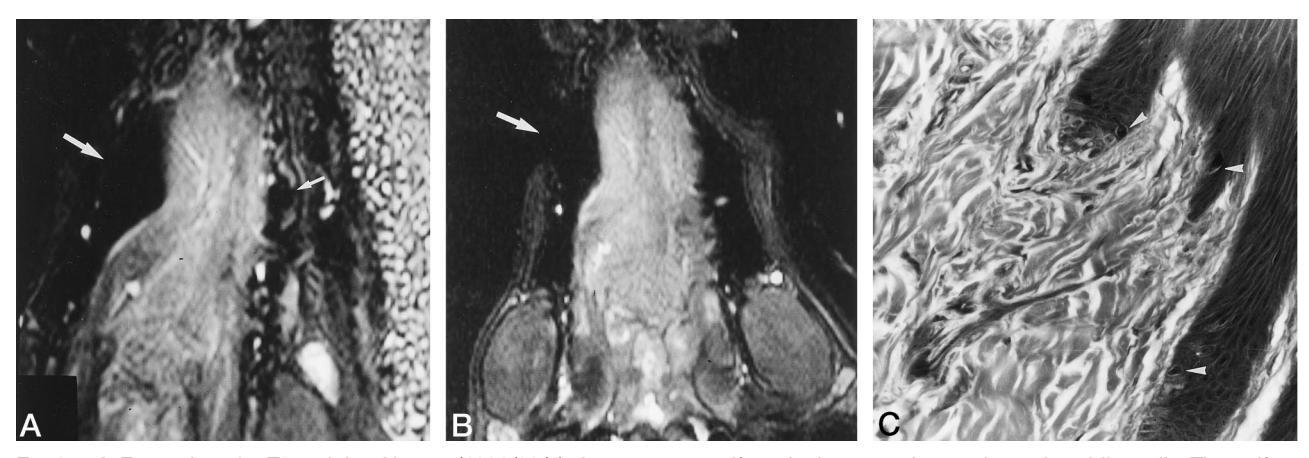
Fig 2. *A*, Fast spin-echo T2-weighted image (4000/99/4) shows severe artifacts in the second premolar regions bilaterally. The artifact on the right (*large arrow*) is larger than that on the left (*small arrow*).

B, Even after the crown on the right premolar has been removed, the artifact remains and is unchanged in size (*arrow*). The crown cemented onto the anterior tooth did not produce any artifact.

C, Tiny fragments of foreign bodies compatible with bur tips (*arrowheads*) can be seen in the gingiva (hematoxylin-eosin, original magnification \times 200).

In both dogs, the MR images showed considerable artifacts in the second premolar regions of the mandible (Fig 2A). The artifact in the right lower premolar region was larger than that in the left. The right premolar region in the mandible produced the same large artifact even after the crown was removed (Fig 2B). The full-cast crown cemented onto the anterior tooth did not produce a significant artifact on MR images. Histopathologic examination detected foreign bodies, so-called bur fragments, in the gingiva (Fig 2C). The right premolar region (subgingival preparation) showed more bur fragments than did the left region. X-ray fluorescent element analysis of the right premolar region showed iron fragments, presumably from the bur tips in the gingival tissue.
