## **Compatibility of cervical spine braces with MR imaging: a study of nine nonferrous devices.**

# Compatibility of Cervical Spine Braces with MR Imaging: A Study of Nine Nonferrous Devices

*AJNR* 11:385-390, March/April 1990

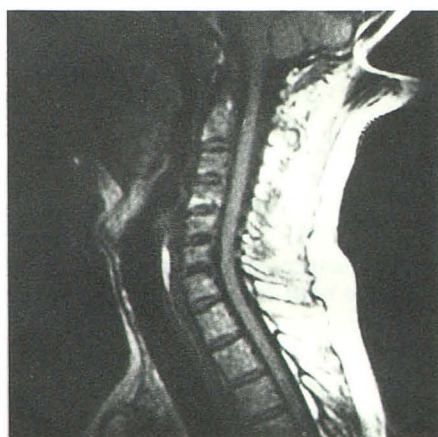
Fig. 3.—T1-weighted cervical spine MR image obtained with the patient wearing a modified Guilford cervical orthosis. Minimal distortion of the posterior cervical soft tissues below the occiput is presumably due to an electrical loop formed by the mandibular and occipital shells.

A T1-weighted cervical spine MR examination on a volunteer fitted with the pink Philadelphia collar with plastic fasteners demonstrated no metal blowout artifacts in the images. Similar results were obtained with the volunteer wearing the modified Guilford cervical orthosis. Although some distortion of the superficial soft tissues in the lower occipital area was present, presumably due to the loop formed by the occipital and mandibular shells, there was no distortion in the region of interest (Fig. 3). Scanning of the cervical spine and the brain in a volunteer fitted with the standard or the prepro-

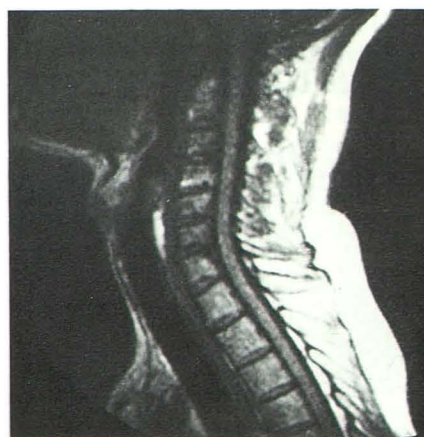
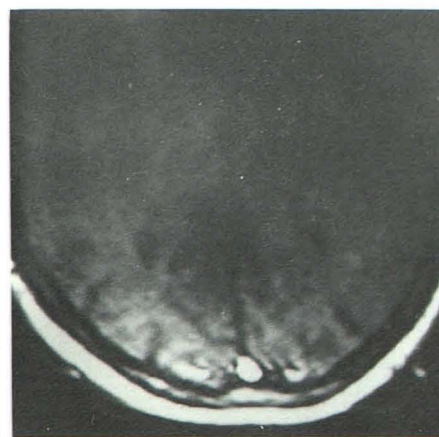
Fig. 4.—A and B, T1-weighted cervical spine (A) and brain (B) MR images obtained with a standard Bremer halo cervical orthosis in place. Cut-off in the anterior aspect of the brain image is due to eddy currents induced within the halo crown by the magnetic field gradients, which alter frequency and phase-encoded spatial information.

duction MR-compatible Bremer halo crown and vest or the standard or the modified PMT cervical orthosis was performed by placing the flat lumbar spine coil between the posterior aluminum rods of the orthosis. The standard Bremer device gave a satisfactory T1-weighted cervical spine examination (Fig. 4A), but the brain examination produced unacceptable images distorted by image cut-off ("loop effect") (Fig. 4B). T1, T2, and gradient-echo images of the volunteer wearing the preproduction MR-compatible Bremer halo system were satisfactory for the cervical spine examination (Figs. 5A–5C). Signal fall-off rendered the T1 brain images suboptimal. However, all areas of the brain could be seen by adjusting level and window settings (Fig. 5D). Brain images obtained with the body coil as the receiver were of diagnostic quality despite some loss in the signal-to-noise ratio and the spatial resolution (Fig. 5E). The standard PMT cervical orthosis introduced no artifacts in the cervical spine images (Fig. 6). T1, T2, and gradient-echo cervical spine and T1-weighted brain scans obtained with the PMT device containing graphite-carbon composite components were acceptable (Figs. 7A–7C), though brain images obtained with the surface coil were again limited by signal fall-off (Fig. 7D).

netic fields sufficiently distort the main magnetic field to degrade the MR images [11]. One device tested, the standard Bremer halo crown and vest, clearly possessed this problem with brain imaging. Interrupting the electrical loop in the halo
