Percutaneous Vertebroplasty: Complication Avoidance and Technique Optimization

John M. Mathis

AJNR Am J Neuroradiol 2003, 24 (8) 1697-1706

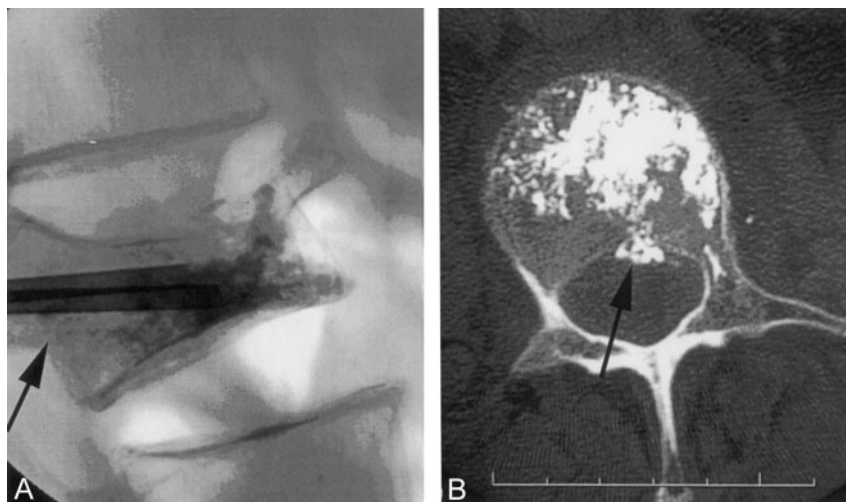
FIG 1. A, Lateral radiograph during vertebroplasty showing cement extending to the posterior vertebral margin (*black arrow*).

B, Post-PV CT scan demonstrates a small leak into the epidural venous plexus (*black arrow*). This leak was asymptomatic.

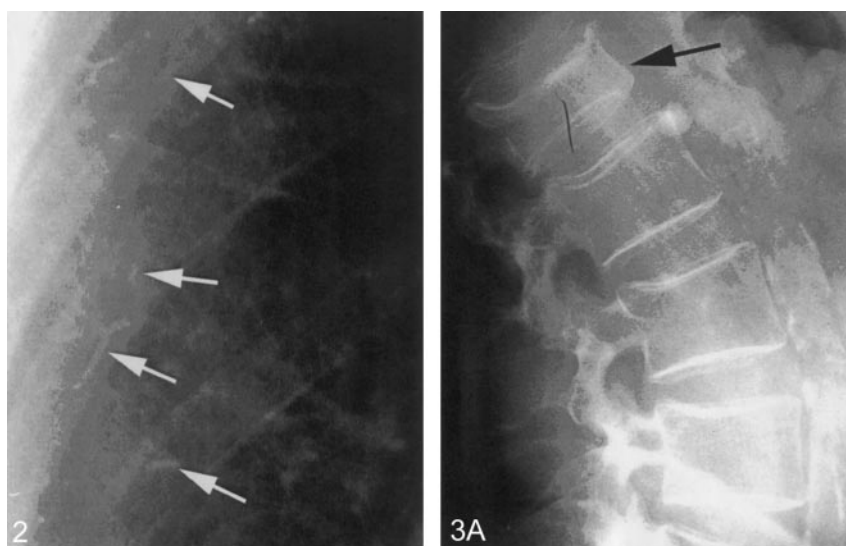
FIG 2. Portion of a chest radiograph after PV showing small radiopaque cement emboli (*white arrows*) in peripheral pulmonary vessels. This patient had no pulmonary symptoms.

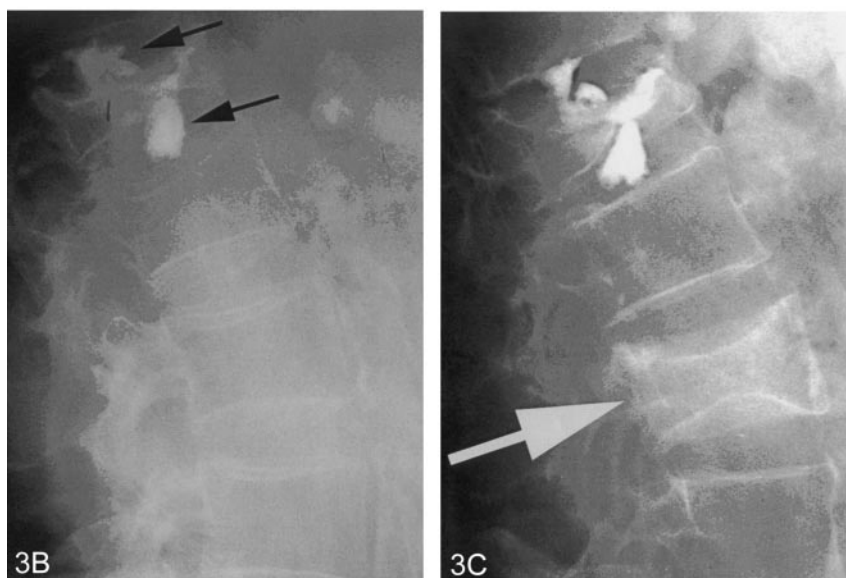
FIG 3. A, Lateral radiograph of the spine showing a moderately compressed vertebra (*black arrow*).

B, Postvertebroplasty, there are large leaks of cement (*black arrows*) into the adjacent disk spaces.

C, Six months later, the patient returned with a second fracture (*white arrow*). This fracture is not an adjacent level. Adjacent levels did not fracture despite the large disk leaks.

are not of consequence if small. There has been speculation that large disk leaks may predispose the adjacent vertebra to collapse. This has not been proved, however, and I have not seen this effect in my practice. Figure 3 demonstrates a subsequent fracture that occurred away from a large disk leak. If a cement leak into the disk predisposes to an adjacent fracture, the statistical confirmation will be hard to obtain, because adjacent-level fractures after PV are known to occur without leak (5, 6).

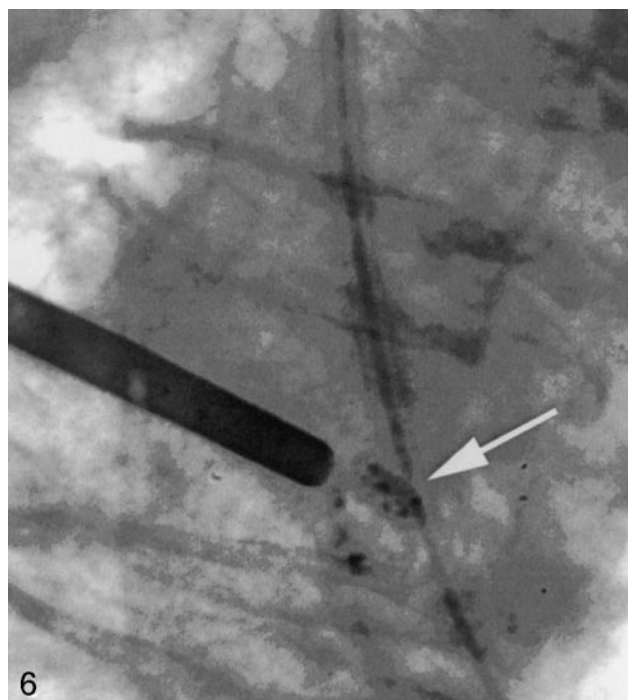
FIG 6. Radiograph showing appropriately opacified cement (white arrow) that can be easily seen even in very small quantities.

Good cement opacification is also crucial to being able to recognize an early cement leak while it is small. Because there is presently no cement specifically made and optimized for PV in the United States, the addition of an opacification agent is required. In the United States, the opacification agent of choice has been barium sulfate. Sterile barium sulfate is added to bring the barium quantity to 30% by weight (8, 9). This allows one to see adequately even small quantities of cement during fluoroscopy (Fig 6).

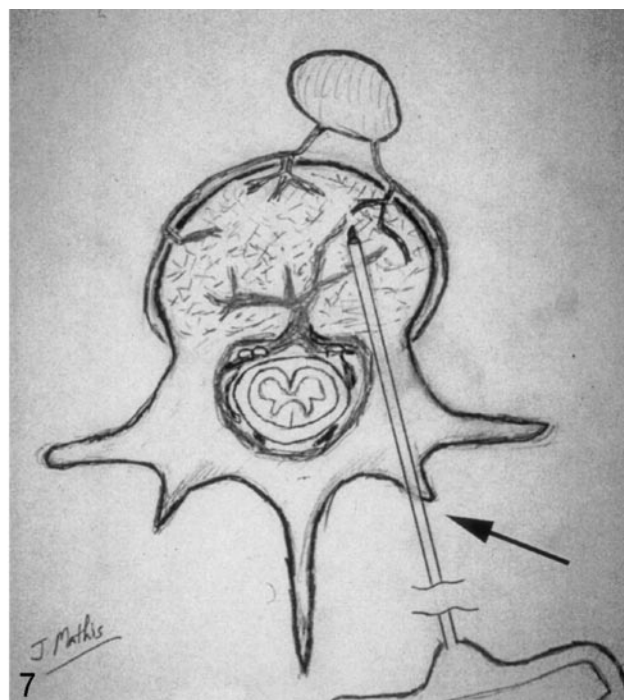
FIG 7. Drawing depicting the needle entry site into the bone (black arrow) for a transpedicular approach. Following removal of the needle, local pressure allows one to easily achieve hemostasis in this situation.

The transpedicular approach places the needle entry site into the bone along the dorsal aspect of the

vertebral posterior element and in a position easily compressed with local skin pressure (Fig 7). This approach, therefore, offers the greatest margin of safety for being able to control local bleeding easily. Parapedicular and posterior-lateral approaches place the needle entry site more laterally and may make hemostasis with local pressure more problematic.

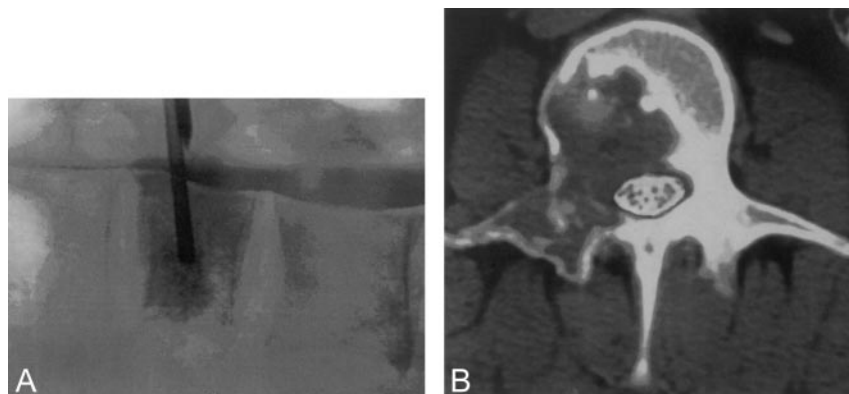
FIG 11. A, Lateral radiograph during vertebroplasty of a compression fracture due to breast carcinoma. Note that the thecal sac was first opacified with myelographic contrast. This allows one to watch for deformation of the thecal sac that would indicate tumor displacement during cement introduction.

B, With the thecal sac opacified, axial CT scans provide the most sensitive method to monitor PV for thecal sac compression created by tumor displaced during cement injection.

may mark the thecal sac by introducing myelographic contrast before the PV. In the lumbar area it is easy to capture the contrast and still use fluoroscopic guidance during the cement injection (Fig 11A). In the thoracic and cervical areas, however, CT becomes very effective for monitoring the injection and looking for cement or tumor that may be displaced into the canal (Fig 11B). CT does not allow easy real-time

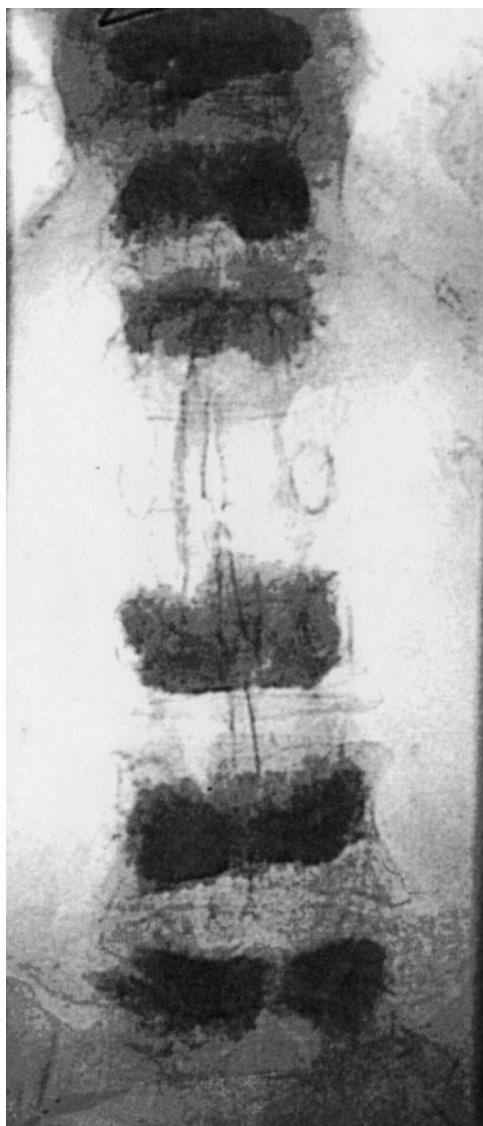
FIG 15. Anteroposterior radiograph showing six vertebrae treated with vertebroplasty. Ultimately, 10 levels were treated in this patient.

Multilevel therapy can be accomplished successfully when approached with caution. Mathis et al reported the first seven-level therapy in 1998 in a 35-year-old lupus patient with multiple compressions secondary to high-dose steroid therapy (22). The treatments were divided, and the patient has had many years without pain or subsequent fracture (with lupus under control and no longer receiving high-dose steroids). I have treated as many as ten levels in a single individual with good results but always dividing therapy into multiple sessions (Fig 15). Prophylactic therapy is still avoided.
