Percutaneous Vertebroplasty: Complication Avoidance and Technique Optimization

John M. Mathis

AJNR Am J Neuroradiol 2003, 24 (8) 1697-1706

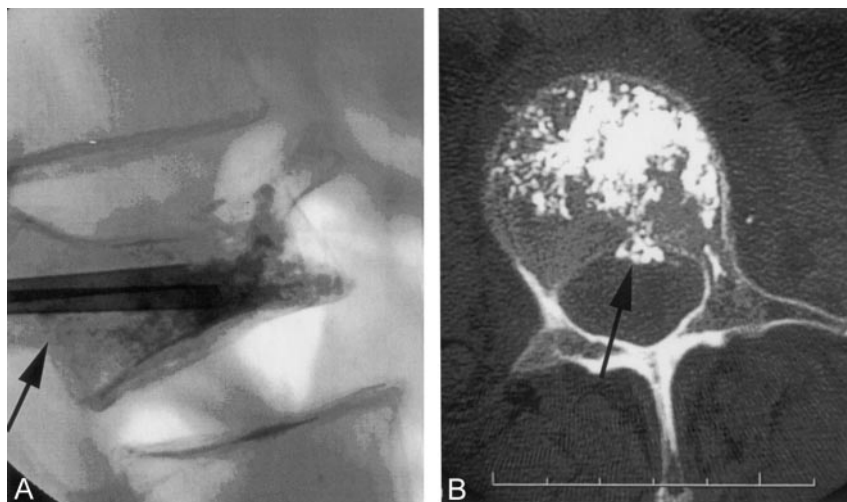
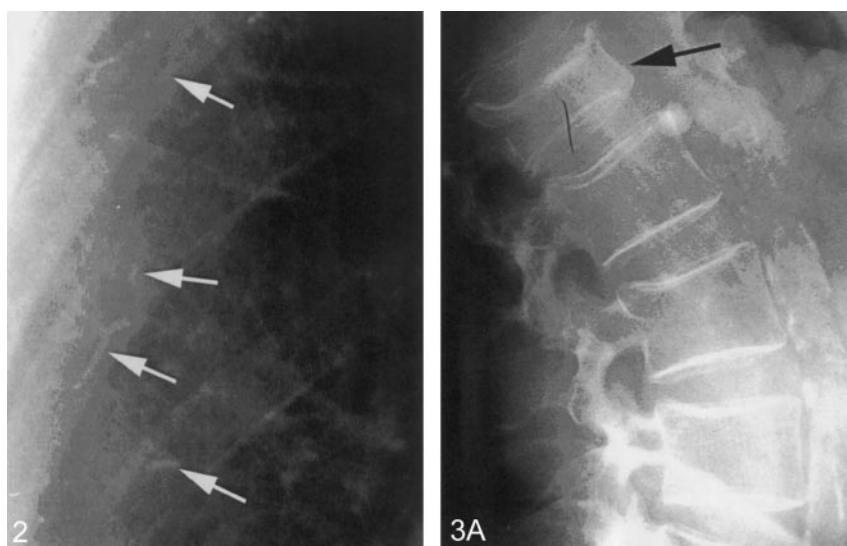
FIG 1. A, Lateral radiograph during vertebroplasty showing cement extending to the posterior vertebral margin (*black arrow*).

B, Post-PV CT scan demonstrates a small leak into the epidural venous plexus (*black arrow*). This leak was asymptomatic.

FIG 2. Portion of a chest radiograph after PV showing small radiopaque cement emboli (*white arrows*) in peripheral pulmonary vessels. This patient had no pulmonary symptoms.

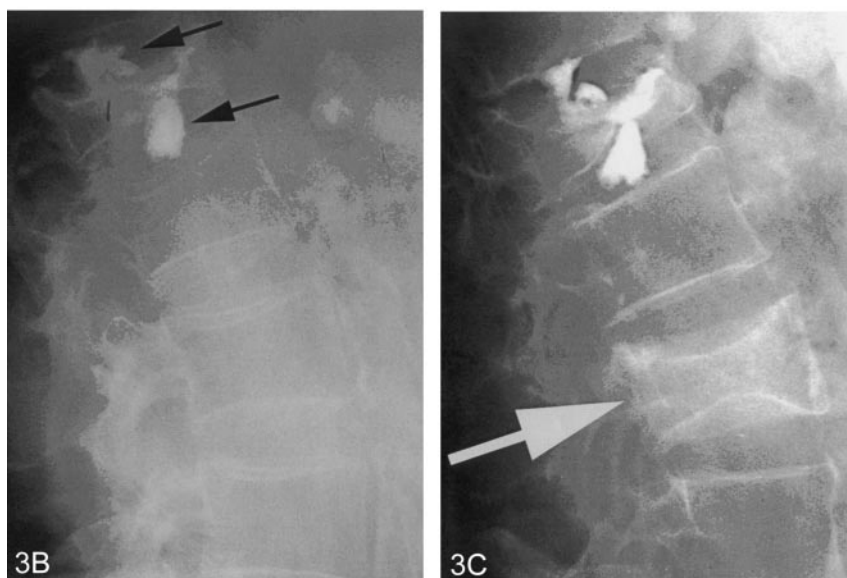
FIG 3. A, Lateral radiograph of the spine showing a moderately compressed vertebra (*black arrow*).

B, Postvertebroplasty, there are large leaks of cement (*black arrows*) into the adjacent disk spaces.

C, Six months later, the patient returned with a second fracture (*white arrow*). This fracture is not an adjacent level. Adjacent levels did not fracture despite the large disk leaks.

are not of consequence if small. There has been speculation that large disk leaks may predispose the adjacent vertebra to collapse. This has not been proved, however, and I have not seen this effect in my practice. Figure 3 demonstrates a subsequent fracture that occurred away from a large disk leak. If a cement leak into the disk predisposes to an adjacent fracture, the statistical confirmation will be hard to obtain, because adjacent-level fractures after PV are known to occur without leak (5, 6).

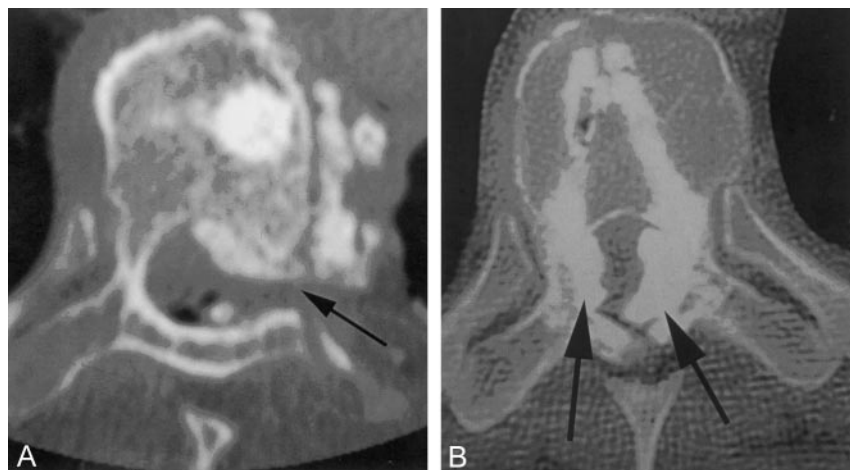
FIG 4. A, Postvertebroplasty CT scan demonstrates large cement leaks into the spinal canal, neural foramin (black arrow), and perispinus region. This patient had paresis and radiculopathy.

B, Postkyphoplasty CT scan shows large leaks into the spinal canal (black arrows), which created paraplegia.

The most common consequence of a severe symptomatic cement leak occurs locally, producing nerve root irritation (resulting in radiculopathy) or cord compression (resulting in myelopathy) (Fig 4). Nerve root irritation may be transient and treatable with nonsteroidal anti-inflammatory drugs or local steroid injections. Persistent pain, however, may require surgical removal of the cement. Cord compression may result in paresis or paralysis. Serious and permanent complications have occurred with both PV and balloon-assisted PV (kyphoplasty; Fig 4). Substantial local cement leaks may also result in local pain exacerbation (7; Fig 5). With any worsening of the clinical situation, a CT scan should be obtained to assess the size and location of a suspected cement leak. A neurologic deficit should trigger an immediate neurosurgical consult. Severe cord compression (resulting in paralysis) and death due to respiratory compromise (caused by large cement pulmonary emboli) have occurred. These complications should be rare or nonexistent and generally result from poor operator technique.

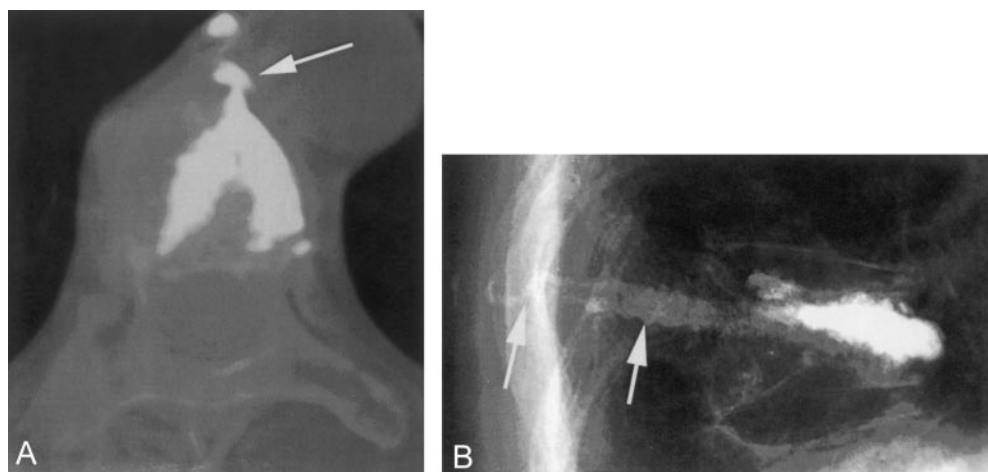
FIG 5. A, Postkyphoplasty CT scan. The lateral wall was disrupted by the balloon inflation, and a large cement leak into the mediastinum resulted (white arrow). For weeks following the procedure, this patient had severe, persistent pain.

B, Lateral radiography after vertebroplasty with a slow-set PMMA. The needles were withdrawn and the cement was still liquid enough to flow into the needle tracts and into the soft tissue (white arrows). This created local discomfort to pressure.

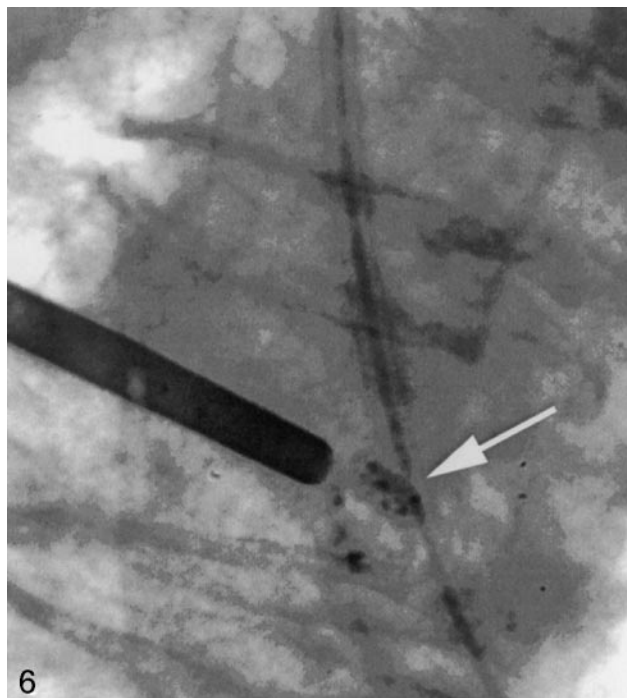
FIG 6. Radiograph showing appropriately opacified cement (white arrow) that can be easily seen even in very small quantities.

Good cement opacification is also crucial to being able to recognize an early cement leak while it is small. Because there is presently no cement specifically made and optimized for PV in the United States, the addition of an opacification agent is required. In the United States, the opacification agent of choice has been barium sulfate. Sterile barium sulfate is added to bring the barium quantity to 30% by weight (8, 9). This allows one to see adequately even small quantities of cement during fluoroscopy (Fig 6).

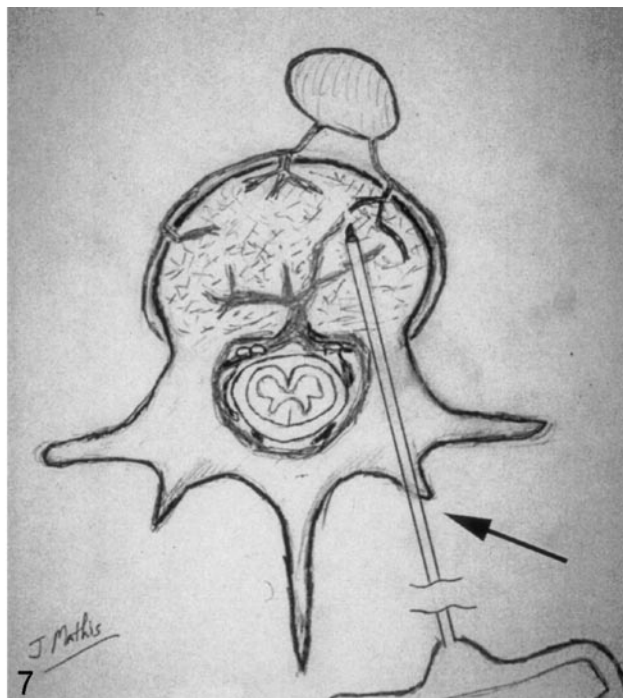
FIG 7. Drawing depicting the needle entry site into the bone (black arrow) for a transpedicular approach. Following removal of the needle, local pressure allows one to easily achieve hemostasis in this situation.

The transpedicular approach places the needle entry site into the bone along the dorsal aspect of the

vertebral posterior element and in a position easily compressed with local skin pressure (Fig 7). This approach, therefore, offers the greatest margin of safety for being able to control local bleeding easily. Parapedicular and posterior-lateral approaches place the needle entry site more laterally and may make hemostasis with local pressure more problematic.

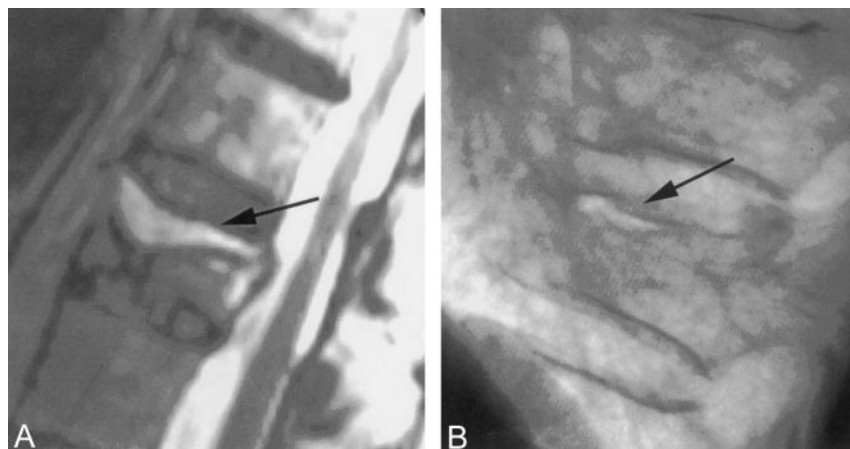
FIG 8. A, T2 sagittal MR imaging demonstrating a high signal intensity collection (black arrow) below the superior endplate of this compressed vertebra. This represents a fluid-filled vertebral cleft.

B, Lateral radiograph showing an air-filled cleft (black arrow) in a compression fracture.

Clefts and Cavities.—Cavities in the vertebral body can form as a result of compression trauma. These areas are often seen on MR imaging (T2 weighting) as bright bands below the endplate (Fig 8A; 15, 16). These cavities are fluid-filled spaces that probably result from local rebound of the endplate following compression, leaving a space that ultimately fills with air or fluid. When filled with air, this cavity (or cleft) can be seen fluoroscopically or radiographically (Fig 8B). These clefts may be an indication of nonunion of the bone and can demonstrate movement of the bone with change in patient position or respiration (17). This motion can be responsible for persistent (or permanent) pain lasting many months after the actual fracture. To treat these fractures adequately, the cavity must be completely filled with bone cement. For-

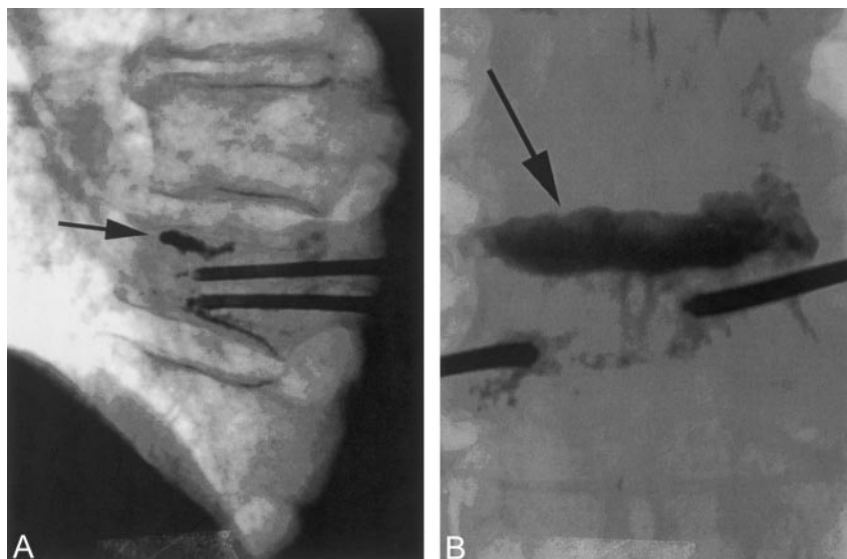
FIG 9. A, Lateral radiograph showing early cement filling of a cleft below the superior endplate (*black arrow*) of a compressed vertebra. Note that the needle tips are separated from the cleft and the cleft is filling preferentially.

B, Anteroposterior view of the same vertebra at completion of the vertebroplasty. The cleft (*black arrow*) has been completely filled with cement. Relatively little cement has been deposited into the rest of the vertebra. This typically results in good pain relief without the need for repeat filling of the noncleft portion of the vertebra.

tunately, this is usually easy to accomplish, because the cement often seeks the cavity preferentially, regardless of position of the needle tip (Fig 9). This pathologic situation also presents an excellent opportunity to achieve some vertebral height restoration during the PV procedure (Fig 10; 18); however, the important point here is that the cleft or cavity must be sufficiently filled to prevent future motion. With this accomplished, these cavities are dependably good responders for pain relief after PV.

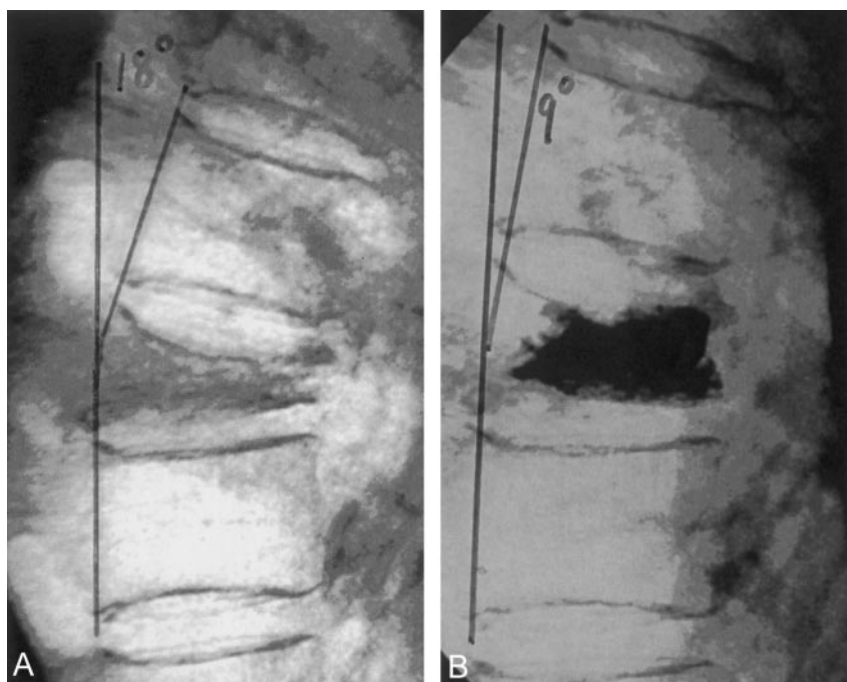
FIG 10. A, Lateral radiograph demonstrating marked compression of a lower thoracic vertebra. Note the 18° of kyphosis before vertebroplasty.

B, With mild extension of the body, some height was restored to vertebra during vertebroplasty. This postvertebroplasty image shows that the kyphosis has been reduced to 9°.

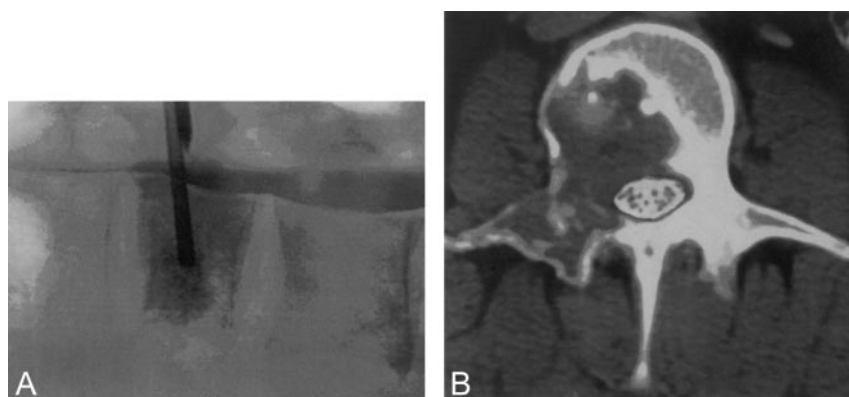
FIG 11. A, Lateral radiograph during vertebroplasty of a compression fracture due to breast carcinoma. Note that the thecal sac was first opacified with myelographic contrast. This allows one to watch for deformation of the thecal sac that would indicate tumor displacement during cement introduction.

B, With the thecal sac opacified, axial CT scans provide the most sensitive method to monitor PV for thecal sac compression created by tumor displaced during cement injection.

may mark the thecal sac by introducing myelographic contrast before the PV. In the lumbar area it is easy to capture the contrast and still use fluoroscopic guidance during the cement injection (Fig 11A). In the thoracic and cervical areas, however, CT becomes very effective for monitoring the injection and looking for cement or tumor that may be displaced into the canal (Fig 11B). CT does not allow easy real-time

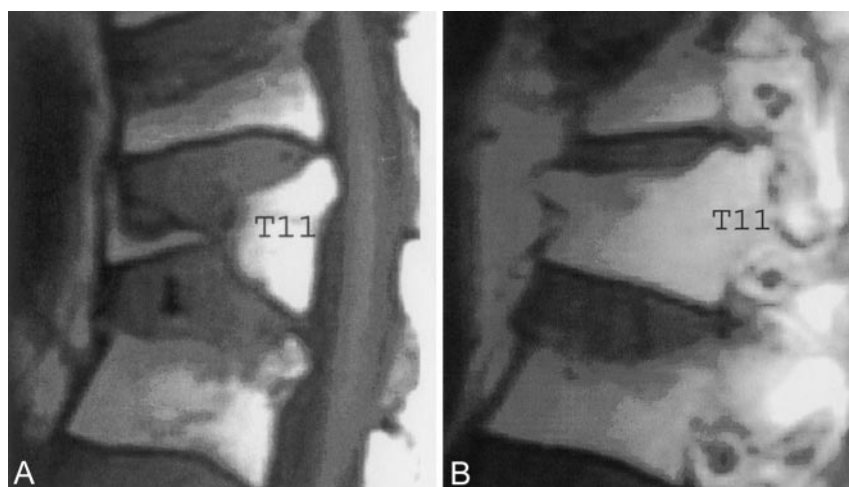
FIG 12. A, Sagittal T1 MR imaging (midline) showing complete central compression of T11.

B, Sagittal T1 MR imaging (lateral vertebral margin) reveals considerable residual marrow space that could be filled with cement during vertebroplasty.

Vertebral Collapse.—Extremely compressed vertebra pose a technical challenge for percutaneous cement augmentation. When compressed more than 75%, just getting a needle into the vertebral body can be difficult; however, we have learned that many of these vertebrae can be treated successfully with PV and produce good pain relief (19, 20). In addition, a vertebra that appears almost completely collapsed may have substantial sparing of its height laterally. This occurs because many vertebrae collapse more in the center than they do along the lateral edges (Fig 12). With care, it is quite common to be able to get a

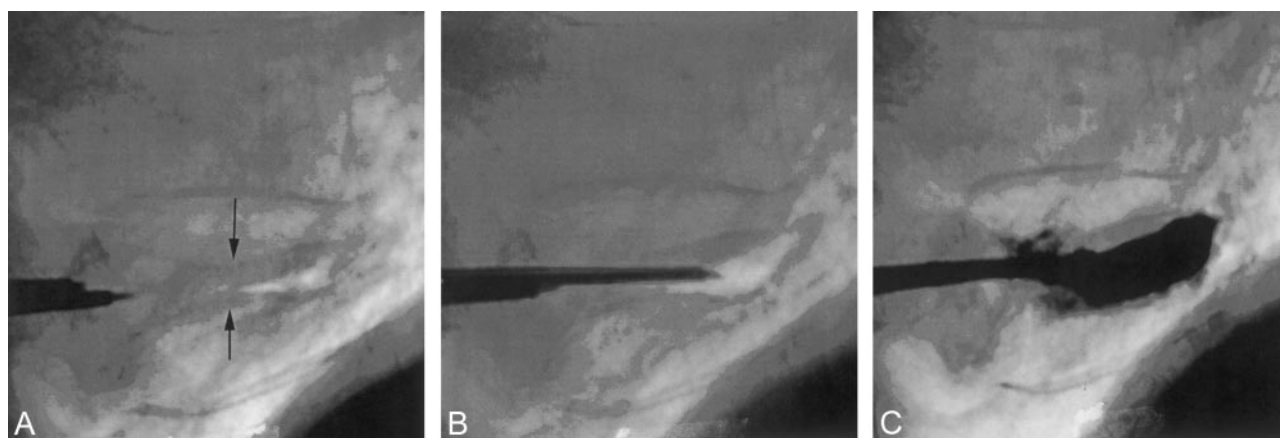
FIG 13. A, Lateral radiograph of an extremely collapsed lower thoracic vertebra. Superior and inferior endplates are identified (black arrows). There is a small air-filled cleft; 13-gauge needles are being introduced via transpedicular route.

B, A lateral image showing one 13-gauge needle in good position before vertebroplasty.

C, Final image after bipedicular vertebroplasty. Good filling of the vertebra was achieved despite the severe collapse. The patient had a good pain response to the procedure.

13-gauge needle system into the lateral aspect of these vertebrae and successfully perform PV (Fig 13). Because of the marked central collapse, a bipedicular approach is useful, because it allows better bilateral vertebral filling. Patients presenting with pain associated with an extreme vertebral collapse should have an attempt at treatment. The amount of cement for this treatment will be smaller than for less compressed vertebra. It is obvious that, because of the challenging technical nature of these compressions, they should not be one's first case. They can, however, present a good opportunity for successful pain relief (20).

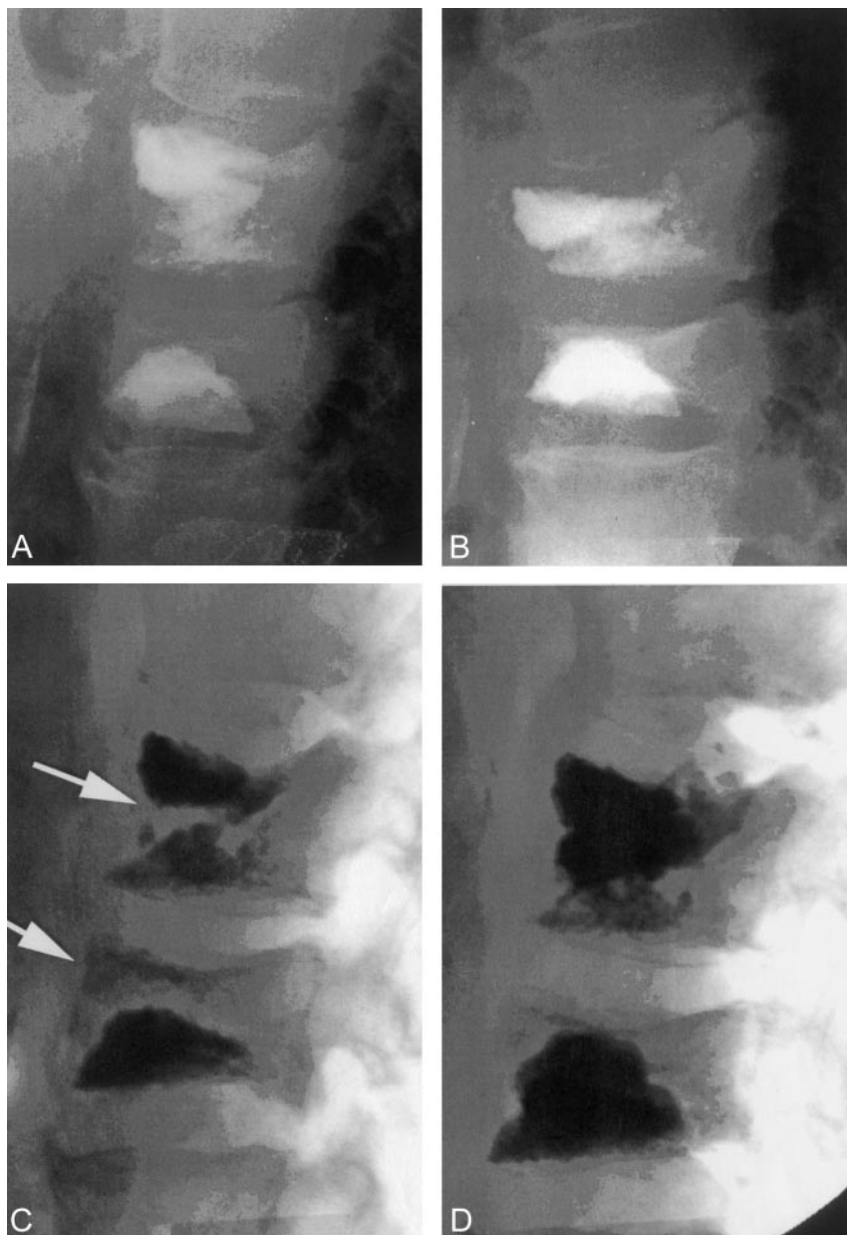
FIG 14. A, Lateral radiograph following a two-level vertebroplasty.

B, Follow-up lateral radiograph after refracture of both previously treated levels. Both levels show height loss compared with image shown in panel A.

C, With the patient placed in mild extension on the angiographic table, the two vertebrae show height restoration and the development of internal clefts (white arrows).

D, The final image following vertebroplasty retreatment. The clefts shown in panel C have been filled with cement. The procedure eliminated the patient's pain, and this fixation has been durable for more than 2 years.

examination is needed to establish that there is no new fracture that would better explain the patient's recurrence of symptoms. When a recurrent fracture is diagnosed, it should be retreated with PV. This can be challenging, because the initial cement can pose a substantial problem for needle placement and injection; however, these vertebrae can be successfully retreated with good pain relief.

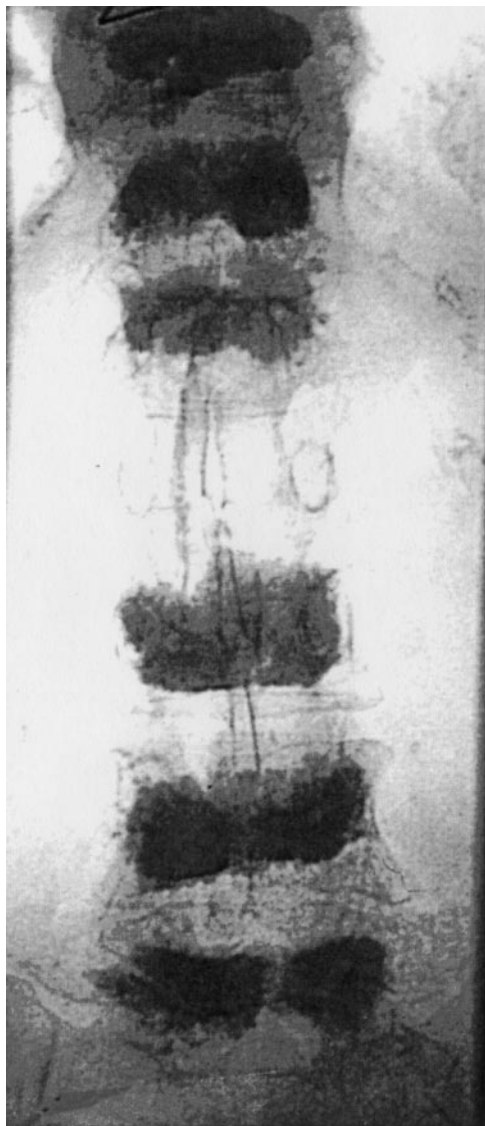
FIG 15. Anteroposterior radiograph showing six vertebrae treated with vertebroplasty. Ultimately, 10 levels were treated in this patient.

Multilevel therapy can be accomplished successfully when approached with caution. Mathis et al reported the first seven-level therapy in 1998 in a 35-year-old lupus patient with multiple compressions secondary to high-dose steroid therapy (22). The treatments were divided, and the patient has had many years without pain or subsequent fracture (with lupus under control and no longer receiving high-dose steroids). I have treated as many as ten levels in a single individual with good results but always dividing therapy into multiple sessions (Fig 15). Prophylactic therapy is still avoided.
