A Technique to Circumvent Subcutaneous Cement Tracts during Percutaneous Vertebroplasty

Timothy J. Kaufmann, John T. Wald and David F. Kallmes

AJNR Am J Neuroradiol 2004, 25 (9) 1595-1596

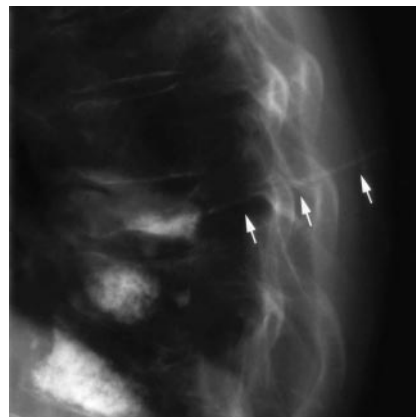
FIG 1. Cement is seen in the needle tract of the subcutaneous tissues of the lower thorax, extending dorsally from the T9 vertebral body cement deposition site (arrows).

We typically employ a moderately viscous cement mixture of powdered Codman cranioplastic polymethylmethacrylate, gentamicin, barium (Parallax Medical, Scotts Valley, CA), and liquid Codman cranioplastic methylmethacrylate monomer in our PV cases (2). On withdrawal of the 13-gauge Osteo-Site needle (Cook Inc., Bloomington, IN) from the T9 vertebra, the cylindrical column of partially solidified cement that was yet in the needle remained in the needle tract from the site of instillation in the vertebral body, through the left pedicle, and into the subcutaneous tissues of the lower thorax, as depicted radiographically (Fig 1).

The patient experienced persistent pain and tenderness at the site of this subcutaneous cement deposition, particularly when sitting on backed chairs. Two months after the procedure, the patient underwent surgical removal of 2.5 cm of the superficial portion of the subcutaneous cement. The surgery was effective in alleviating her pain.

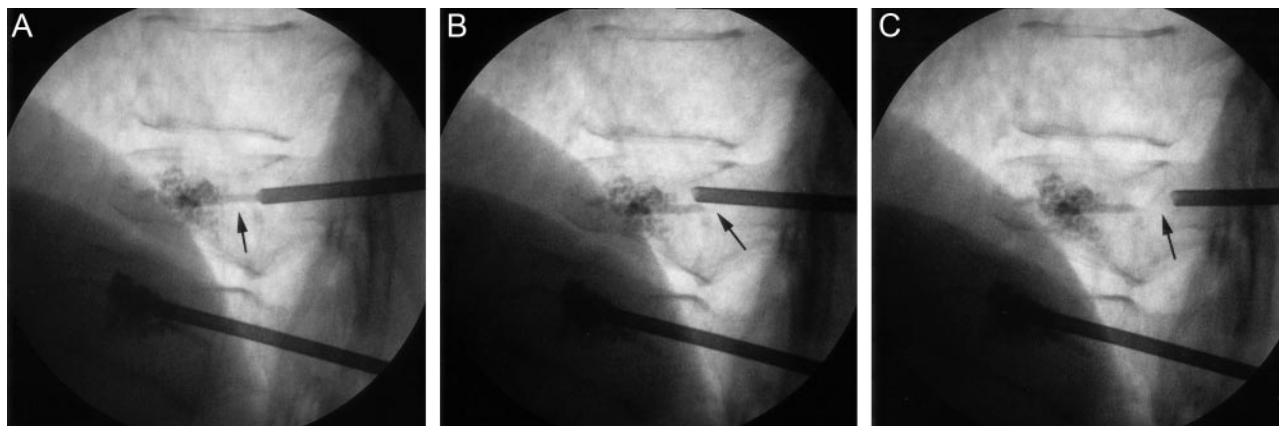
FIG 2. Deposition of a subcutaneous cement tract is averted.

A, Cement column, visualized in the posterior T11 vertebral body (arrow) as needle withdrawal is first begun.

B, The cement column inside the needle is broken at the tip of the needle (arrow) by pulling the needle hub inferiorly and advancing the tip of the needle toward the superior endplate.

C, The needle can then be withdrawn without further cement deposition in the needle tract (arrow).

We used 11-gauge Osteo-Site needles and the cement mixture described in case 1. Following cement instillation through the left T11 pedicle, we noticed that as the needle was being withdrawn with its tip still within the posterior aspect of the vertebral body, the core of partially solidified cement within the needle was being deposited in the needle tract (Fig 2A). Despite multiple attempts at breaking the cement core by rotating the needle and advancing and withdrawing the needle, the column of cement remained unbroken.

To prevent the deposition of a subcutaneous cement tract, the needle tip was then redirected superiorly and advanced toward the superior endplate, which cut completely through the column of cement (Fig 2B). This maneuver disconnected the cement deposited in the vertebral body from that which remained in the needle and allowed the needle to be subsequently withdrawn completely without depositing cement within the needle tract (Fig 2C).

We describe a simple maneuver in case 2 that can avert this complication. This technique may be employed during needle removal as soon as it is recognized that cement deposition is occurring in the needle tract. As needle position within the vertebral body may differ in other cases, the needle may be advanced forward across the cement column to cut it in any direction that is safe, with care taken to remain within the vertebral body and to avoid transgression of a vertebral endplate. The need for this technique should not be frequent, but we have used it successfully in two patients since case 1.
