**Refracture with Cement Extrusion Following
Percutaneous Vertebroplasty of a Large
Interbody Cleft**

AJNR Am J Neuroradiol 2006, 27 (1) 230-231

CASE REPORT

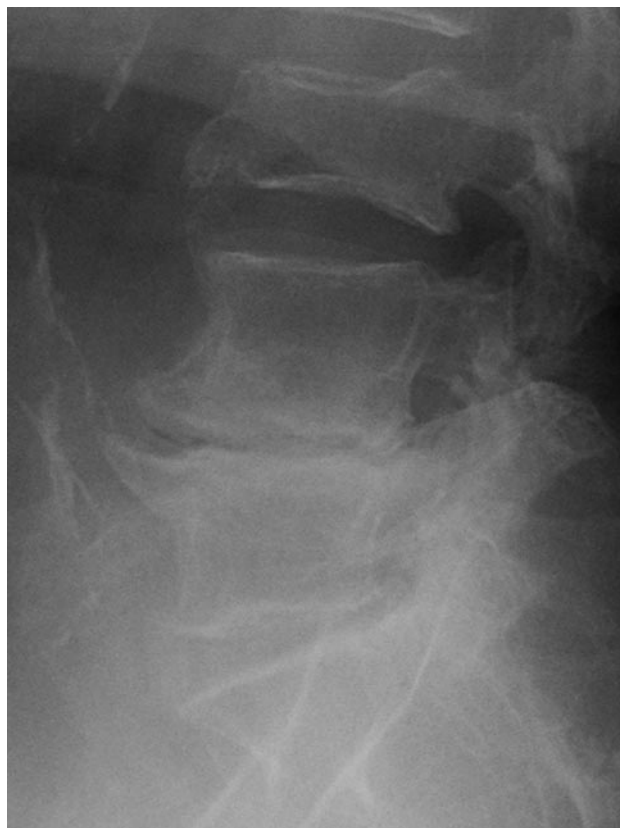
Fig 1. Lateral radiograph of the lumbar spine before initial vertebroplasty reveals compression of the L3 vertebral body with little anterior wall bowing.

A 75-year-old diabetic woman, who had been on dialysis for >20 years, presented with a 3-month history of severe back pain, unresponsive to bed rest, analgesics, and bracing. Sequential plain films showed severe diffuse osteopenia and a compression fracture at L3 that had progressed from 20% height loss at initial presentation to 60% height loss over a short period of time (Fig 1). Physical examination demonstrated marked tenderness upon palpation of the posterior spinous process of L3, and vertebroplasty was ordered, because of her rapidly progressing fracture. Vertebroplasty was performed by using an 11-gauge needle via a unipedicular approach, and it was immediately noted that the cement was filling a large cavity within the L3 vertebral body.

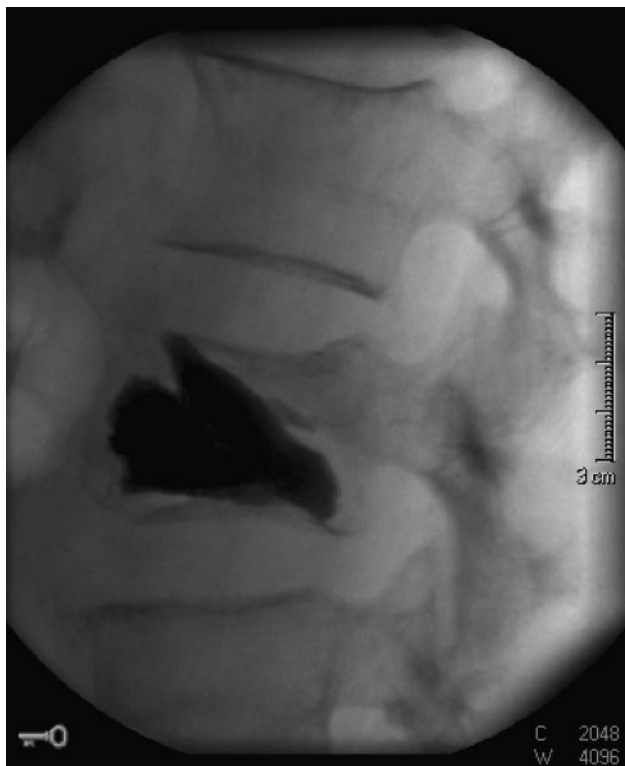
Fig 2. Lateral view of the L3 vertebral body at the conclusion of vertebroplasty demonstrates cement extending throughout the anterior and middle portions of the vertebral body, filling a large cleft. The presence of the cleft is confirmed by the solid appearance and sharp outer borders of the cement bolus.

Cement was injected until a pressure end point was reached and was no longer filling the cavity, at which point the procedure was terminated. Although she experienced some mild relief at first, the patient continued to have pain in the same area. MR imaging was performed and demonstrated incomplete filling of the cavity around the existing cement and some marrow edema at the L3 level, with no other explanation for the patient's pain. A second procedure was performed from the opposite side, with resultant filling of the additional cavity (Fig 2), and repeat MR imaging 2 weeks later demonstrated good filling of the cavity with no significant residual edema. The patient continued to have some back pain until approximately 1 month after the second procedure, when she experienced a sudden, severe

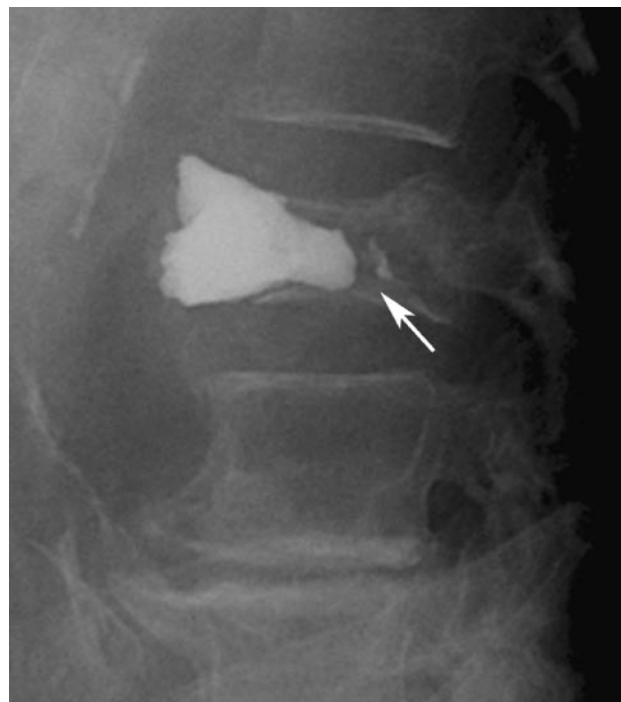
Fig 3. Lateral radiograph of the lumbar spine following a severe acute exacerbation of the patient's back pain reveals that the posterior portion of the vertebral body has collapsed further since the prior MR imaging, with 1 cm of anterior displacement of the intravertebral cement, which now projects well past the anterior spinal line. Note the reduced attenuation in the inferior L3 vertebral body corresponding to where the cement was initially located as well as a small amount of cement remaining in the original location (arrow).

onset of unrelenting back pain more severe than any previous episodes. Repeat conventional radiographs at that time demonstrated that the patient had compressed the posterior 25% of the L3 vertebral body, and the cement bolus within the vertebral body had been displaced anteriorly approximately 1 cm into the retroperitoneal space (Fig 3). At this point, the patient refused any more therapy, elected to stop dialysis treatment, and died soon thereafter.

to have been strong enough to support the large volume of cement injected into the vertebral body, with postprocedure posterior vertebral fracture causing anterior cement extrusion. Although this is a rarely seen complication that has only been described twice, it does raise the question whether in certain patients, such as those on dialysis or with secondary drug-induced osteoporosis, and who have vertebral clefts, the marrow space should also be bolstered with cement, to prevent further collapse.
