**Unintended Consequences: Review of New
Artifacts Introduced by Iterative
Reconstruction CT Metal Artifact Reduction
in Spine Imaging**

AJNR Am J Neuroradiol 2019, 40 (11) 1973-1975

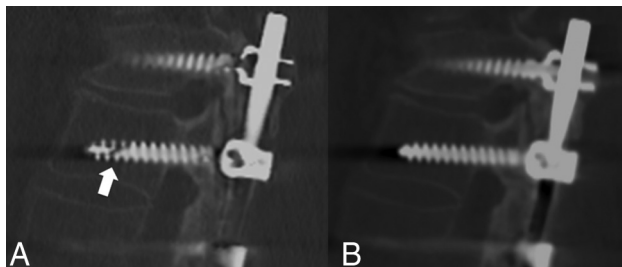
FIG 3. A, Sagittal CT image of posterior spinal fusion of the MAR protocol demonstrating lucency through the pedicle screw (white arrow). This lucency clearly mimics a fracture, hence could be called a “pseudofracture” if non-MAR images are not available. B, Image without the MAR application shows a normal appearance of the pedicle screw.

Pedicle Screw Lucency. Pedicle screw lucency occurs when the implanted hardware fatigues and fractures (Fig 3*A*, *white arrow*), which is not seen on the non-MAR image (Fig 3*B*). This artifact is not uniform throughout the MAR series, and adjacent images demonstrate that adjacent screws are unaffected.

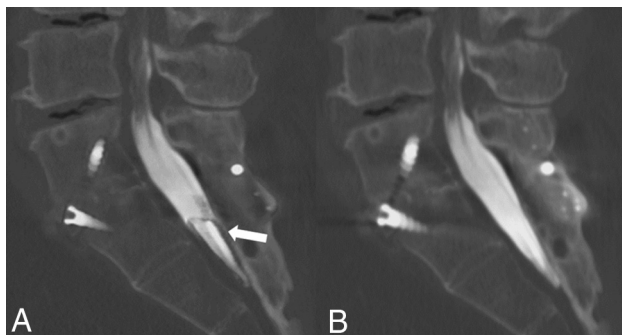
FIG 4. A, Sagittal MAR CT image with fusion hardware in the lumbar and sacral spine demonstrates apparent hypodense material (white arrow) in the dorsal spinal canal not seen in the non-MAR image. This filling defect could be mistaken for arachnoiditis, tumor, or layering debris and lead to unnecessary further work-up. B, Non-MAR image without evidence of material within the spinal canal.

Subarachnoid Material on Myelography. Factitious subarachnoid material can be seen on myelograms when MAR is applied, particularly in areas of concentrated intrathecal contrast. There is hypodense material in the dorsal spinal canal (Fig 4*A*, *white arrow*), which is not seen on the non-MAR image (Fig 4*B*). This artifact could be mistaken for arachnoiditis, tumor, or layering debris and may lead to unnecessary further work-up.
