## **Unintended Consequences: Review of New Artifacts Introduced by Iterative Reconstruction CT Metal Artifact Reduction in Spine Imaging**

D.R. Wayer, N.Y. Kim, B.J. Otto, A.M. Grayev and A.D. Kuner

*AJNR Am J Neuroradiol* published online 3 October 2019  
<http://www.ajnr.org/content/early/2019/10/03/ajnr.A6238>

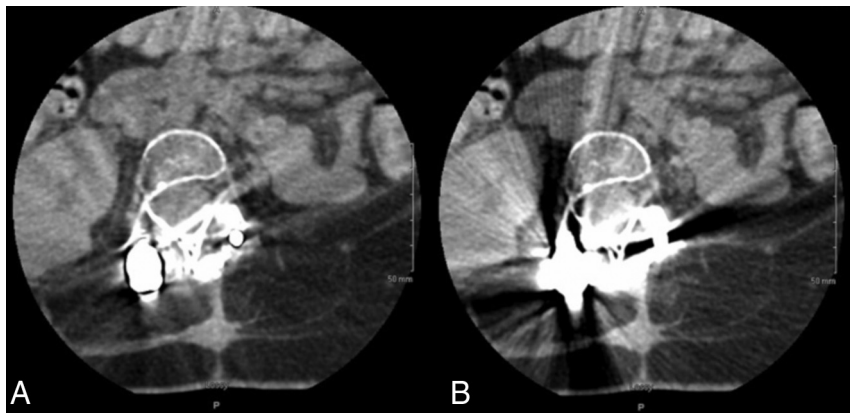
**FIG 1.** Axial lumbar CT images of a 15-year-old boy with spinal muscular atrophy type II who underwent posterior spinal fusion of T2–L5 due to severe scoliosis. *A*, MAR images demonstrating improved visualizations of soft tissues surrounding the hardware. *B*, Uncorrected images show artifacts covering soft tissues surrounding the hardware.

MAR reconstruction has been shown to significantly improve visualization of obscured soft-tissue structures and diagnostic confidence compared with the standard weighted filtered back-projection reconstruction method.<sup>12</sup> Paraspinal soft tissues adjacent to the fusion hardware are obscured on traditional images, while the MAR image allows adequate visualization of the underlying structures (Fig 1). Despite the clear benefits of applying MAR to decrease metal artifacts, MAR introduces its own unique artifacts.

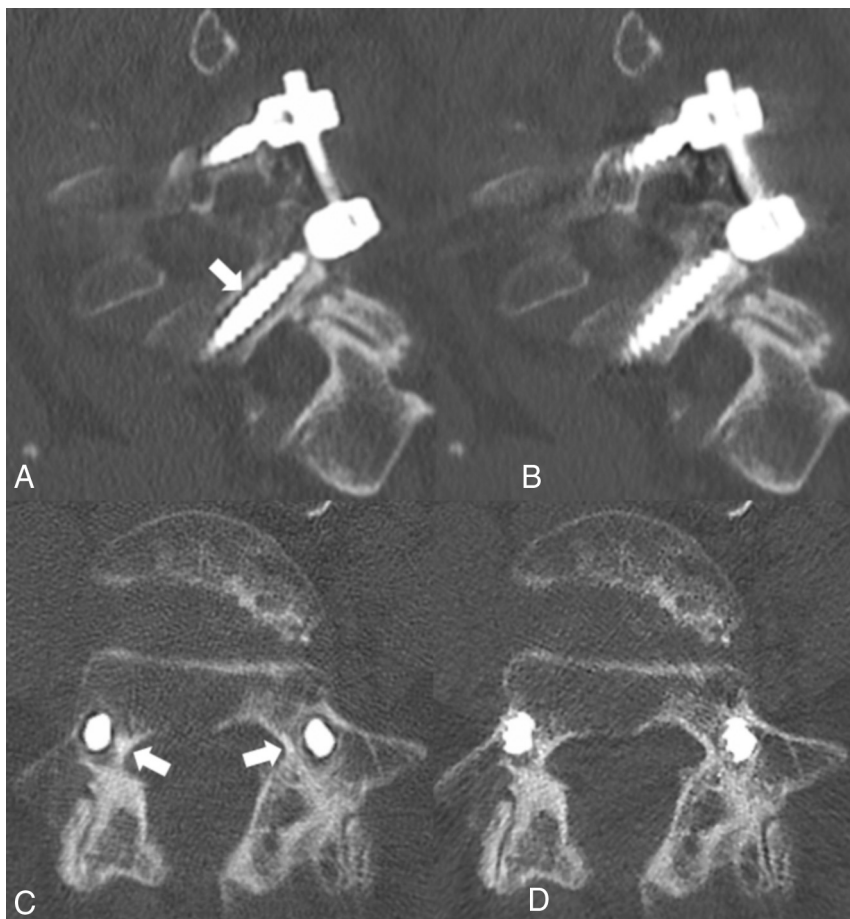
**FIG 2.** *A*, Sagittal CT image of posterior lumbar spinal fusion with the MAR technique applied shows lucency surrounding the L5 pedicle screw as indicated by the *white arrow*. *B*, Image *A* without the MAR protocol applied. *C*, Axial CT image shows bilateral pedicle screws with the MAR technique applied, demonstrating lucency surrounding the bilateral pedicle screws (*white arrows*). If the MAR images were viewed alone, these lucencies could be mistaken for hardware loosening. *D*, Image *C* without the MAR protocol applied.

**Perihardware Lucency.** Perihardware lucency (Fig 2A, white arrow) is concerning because it usually signifies loosening of the hardware; however, this is not visualized in the non-MAR images

(Fig 2*B*). More troublesome is that these artifacts persist in multiple planes as shown in the axial plane (Fig 2*C*, *-D*).

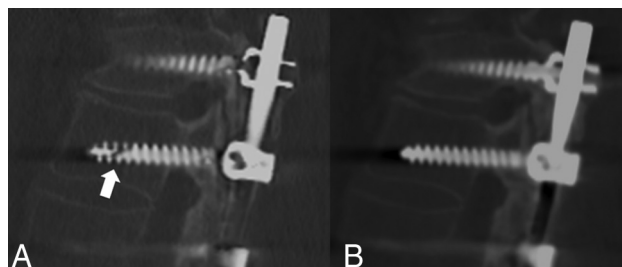
**FIG 3.** A, Sagittal CT image of posterior spinal fusion of the MAR protocol demonstrating lucency through the pedicle screw (white arrow). This lucency clearly mimics a fracture, hence could be called a “pseudofracture” if non-MAR images are not available. B, Image without the MAR application shows a normal appearance of the pedicle screw.

**Pedicle Screw Lucency.** Pedicle screw lucency occurs when the implanted hardware fatigues and fractures (Fig 3*A*, *white arrow*), which is not seen on the non-MAR image (Fig 3*B*). This artifact is not uniform throughout the MAR series, and adjacent images demonstrate that adjacent screws are unaffected.

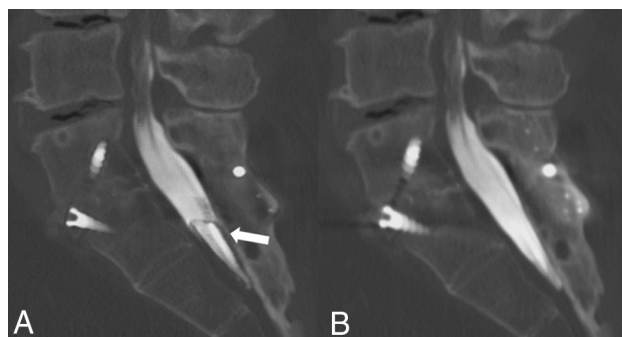
**FIG 4.** A, Sagittal MAR CT image with fusion hardware in the lumbar and sacral spine demonstrates apparent hypodense material (white arrow) in the dorsal spinal canal not seen in the non-MAR image. This filling defect could be mistaken for arachnoiditis, tumor, or layering debris and lead to unnecessary further work-up. B, Non-MAR image without evidence of material within the spinal canal.

**Subarachnoid Material on Myelography.** Factitious subarachnoid material can be seen on myelograms when MAR is applied, particularly in areas of concentrated intrathecal contrast. There is hypodense material in the dorsal spinal canal (Fig 4*A*, *white arrow*), which is not seen on the non-MAR image (Fig 4*B*). This artifact could be mistaken for arachnoiditis, tumor, or layering debris and may lead to unnecessary further work-up.

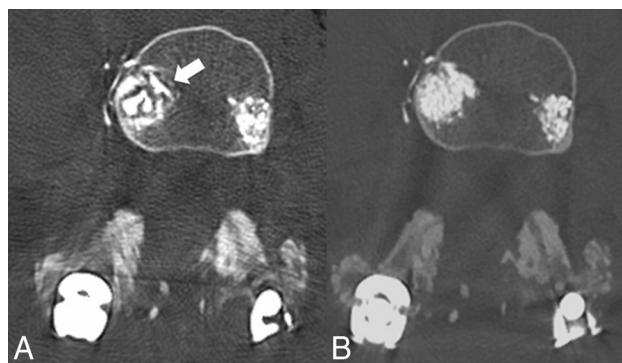
**FIG 5.** A, Axial CT image with MAR applied demonstrating an irregular fragmented appearance of bone cement with indistinct margins (white arrow). B, Non-MAR counterpart image with normal appearance of bone cement with accurate representation of vertebral filling.

**Intraosseous Cement Abnormal Distribution.** Postvertebroplasty cement configuration can appear irregular and fragmented with indistinct margins (Fig 5*A*, *white arrow*) and an internal heterogeneous pattern of vertebral body filling; however, in the non-MAR image (Fig 5*B*), the bone cement has a normal uniform distribution with clearly defined margins.
